Manhole Inspection Summary

Manhole # S05EE2004MH

Insp Date: **7/17/06 12:00 AM**

Location Address: **2708 BARTOL AVE**

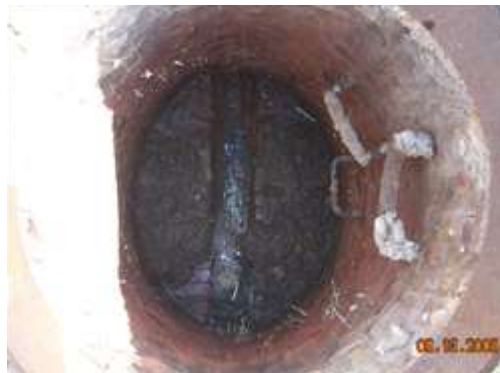
Top View

Corroded steps. Evidence of surcharge - Bench debris.

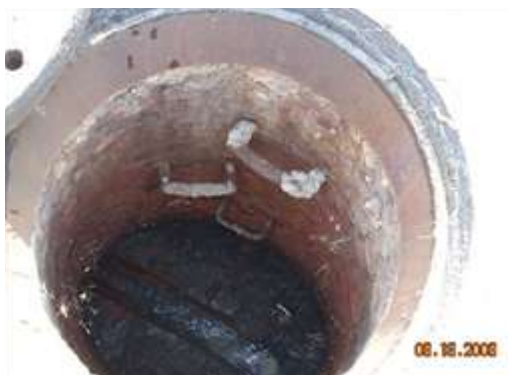
Defect

Frame Offset: **0** (in.) Condition: ☐ Sound ☐ Cracked ☒ **Leaks**

Condition: ☐ Sound ☐ Cracked ☐ Root Intrusion ☐ Loose Brick ☒ **Deteriorated**

Infiltration: ☐ None ☒ **Joint** ☐ Cracks ☐ Mortar ☐ Roots ☒ **Wall**

Frame leaks. Adjustment deterioration and infiltration. Corbel and Barrel infiltration.

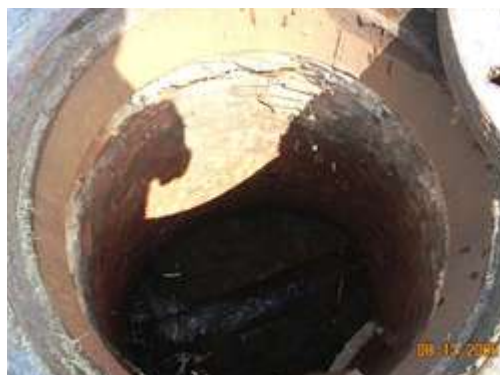
Defect

Frame leaks. Adjustment deterioration and infiltration. Corbel and Barrel infiltration - other side.

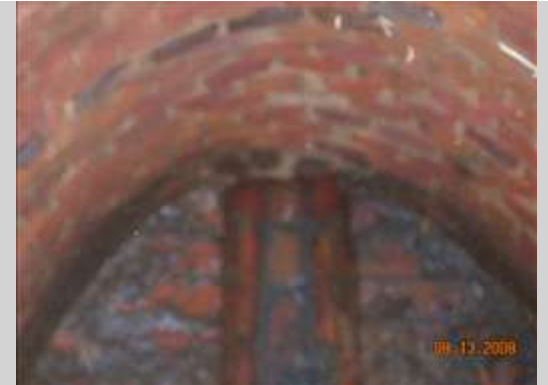
8 in. Circular Gravity Sewer Pipe Out @ 12 O'Clock

Infiltration: **None** Pipe Seal Cond: **Broken**

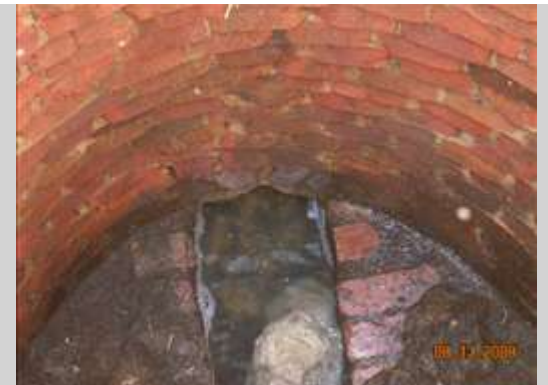
8 in. Circular Gravity Sewer Pipe In @ 6 O'Clock

Deposits: ☐ None ☒ **Mud** ☐ Sludge ☒ **Debris** ☐ Grease

Silt Depth: **2** (in.) Deposits Extent: **Medium**

Infiltration: **None** Pipe Seal Cond: **Broken**
